**Report Number: 214-TRC-03-010**

**Safety Compliance Testing For FMVSS 214**

**2003 Mercedes-Benz C240 4-door Sedan**

**Transportation Research Center Inc.**

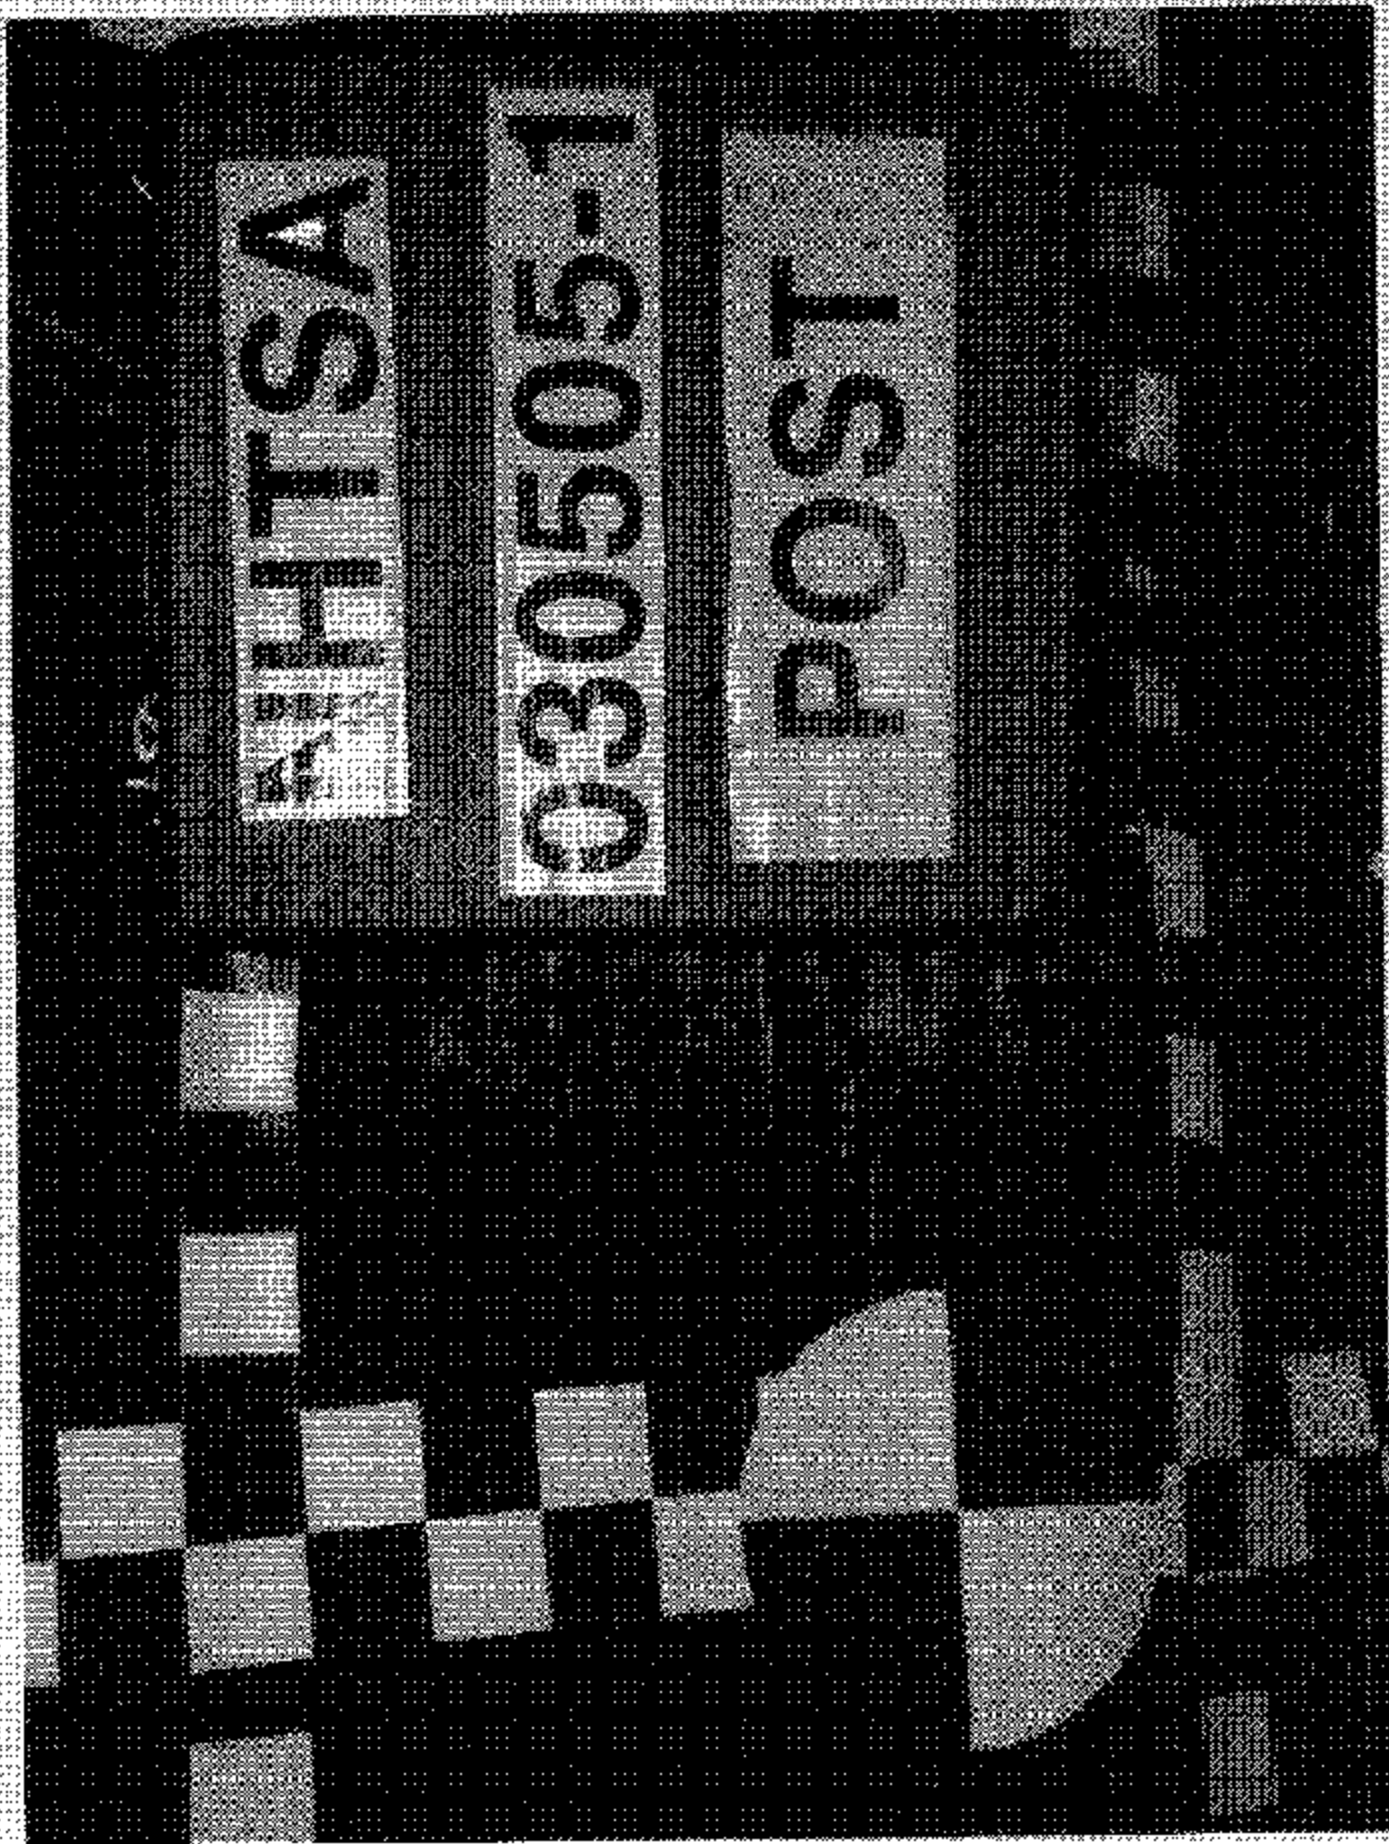
Figure A-45 Post-Test Primary Impact Point View
